Caribbean Roofing 101

By Derek Hodgin, P.E., RRO

I first flew to Grand Cayman in the fall of 1998 to perform my assessment of the existing roof and provide my recommendations for a new roof for the Christopher Columbus, a beautiful condominium resort at the north end of Seven Mile Beach.

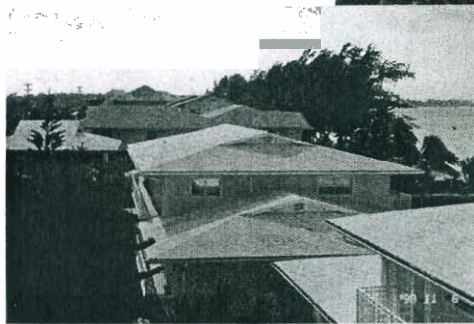
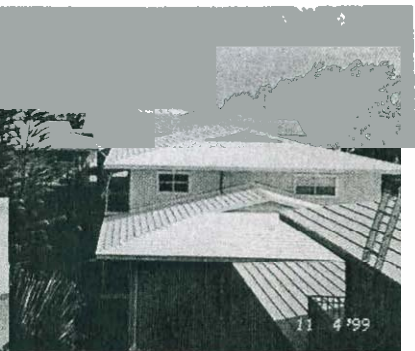
Three of the four buildings in the Christopher Columbus resort are visible in this photo (before reroofing, left, and after, right). (Derek Hodgin photos)

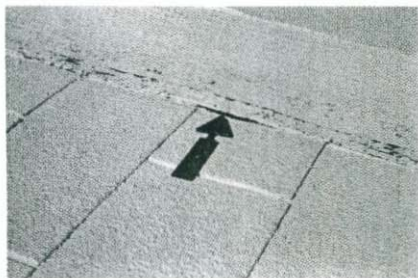
the roof was a bad combination. The paint was observed to bridge between overlying shingle tabs in some areas but not in others. Due to the low slope of the roof, the shingles were vulnerable to water penetration during high winds. Once the water penetrated the shingles, it could migrate laterally and become trapped under the elastomeric coating. Evidence of long-term water intrusion was noted in the discoloration of the white roof surface caused by corrosion of underlying roofing nails and soft areas in the plywood roof deck which were detected while walking on the roof.

The old roof shingles are covered here with an elastomeric coating. The arrow points to a gap in the roof which allowed moisture to penetrate and corrode metal flashings.

I am now convinced that my original assertion that the elastomeric coating was trapping water was correct. The extent of plywood damage, and the significant corrosion

of the roofing nails and flashing, was the direct result of long-term exposure to this trapped moisture.

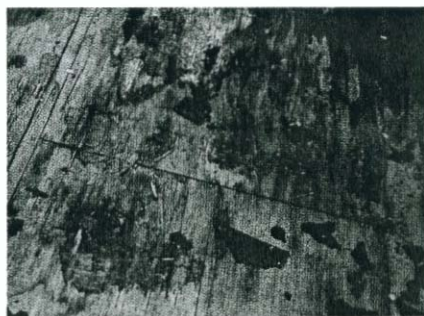
Damage from moisture intrusion also ruined vast expanses of the plywood roof decking, which had to be replaced.

As the shingles were being scraped away, it was quickly apparent that the middle of a large plywood area was completely rotten. I expected the roof deck to be deteriorated (water stained, delaminated, minor decomposition) in some areas, but not rotten. The wood was dark brown to black in color and extremely soft. If the plywood was this bad in the field, I figured it would be even worse at the eaves. As more of the roof was torn off, my fears were realized; the wood rot was widespread with no discernible pattern.

If the extent of rotten plywood was similar on the remaining roof areas, the plywood replacement allowance would be drastically exceeded. The contract provided for an allowance of 10 sheets of plywood replacement. In the end, 128 sheets were needed, costing the owners of the buildings considerably more than originally allowed.
