# COMPARISON OF STRENGTH PROPERTIES AND FAILURE CHARACTERISTICS BETWEEN FIRE-RETARDANT-TREATED AND UNTREATED ROOF FRAMING LUMBER AFTER LONG-TERM EXPOSURE: A SOUTH CAROLINA CASE STUDY

DEREK A. HODGIN\*  
ANDY W.C. LEE\*

Forest Prod. J. 52(6):91-94.

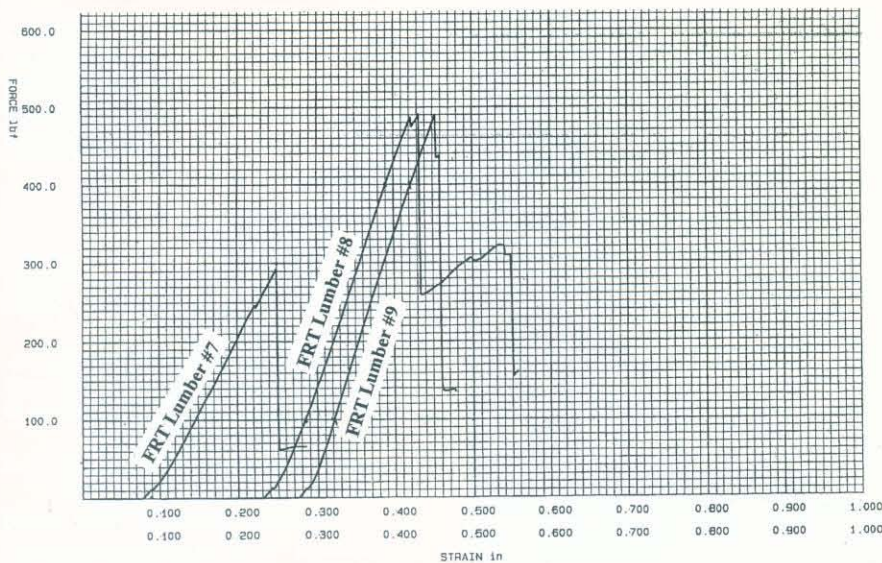
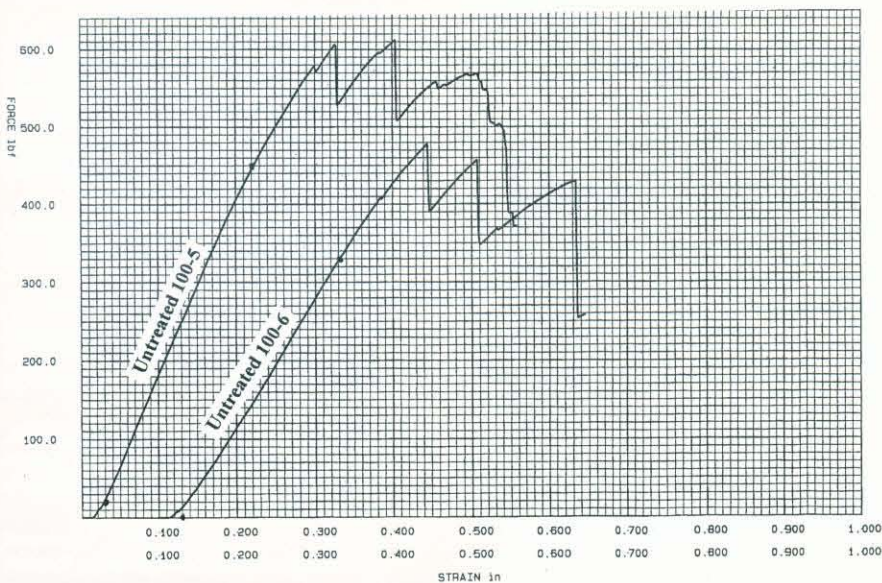
The plots (stress vs. strain) of the test data for the treated wood samples just described typically showed an abrupt mode of failure (**Fig. 1**). These plots included a relatively linear and proportional stress/strain relationship early in the test. However, when failure occurred, the load-carrying capacity of the treated specimens dropped suddenly. The abrupt failure of the treated specimens is depicted by a sharp truncation on the final stage of the test plot. This portion of the test plot typically includes a nearly vertical drop indicating the rapid loss of the specimen's load-carry-

ing capacity. This sharp truncation reduces the area below the stress/strain curve, which is directly related to toughness. The brash and sudden failure contributes to the reduced toughness of the treated specimens (**Fig. 2**).

Figure 1. — Recording plots of static bending tests of FRT wood samples (top) and untreated wood samples (bottom).

The plots (stress vs. strain) of the untreated wood samples just described typically showed a less abrupt mode of failure (Fig. 1). Specifically, failure occurred more gradually with the load-car-

rying capacity of the specimen dropping in a more “stepped” fashion on the final stage of the test plot. The ability of the untreated specimens to continue carrying load after initial failure greatly increased the area below the stress/strain curves, which represents the toughness of the samples. Therefore, these test plots indicate that the toughness of the untreated samples is much greater than that of the treated samples. The more gradual and less brash mode of failure of the untreated samples (Fig. 2) is attributed to the increased toughness.

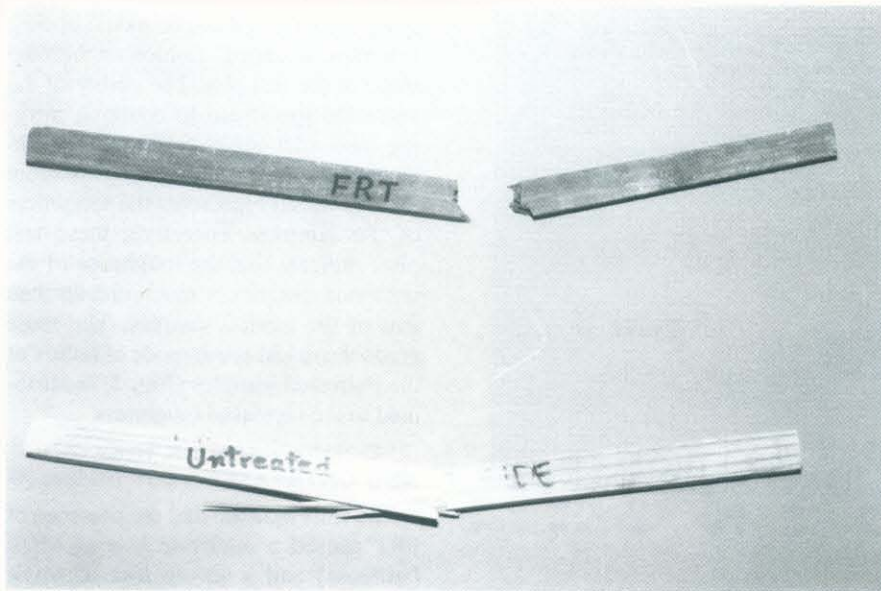
The brittle condition of the treated wood samples is associated with a significant reduction of toughness. The loss of toughness in the treated wood resulted in a sudden and brash failure. In contrast, the untreated wood samples were able to continue carrying load after initial failure. The mode of failure for the untreated samples was more gradual and resilient in nature.

Figure 2. — Failure modes of static bending tests of FRT wood sample (top) and untreated wood sample (bottom).
