METAL ROOFING

Caribbean Roofing 101

By Derek Hodgin, P.E., RRO

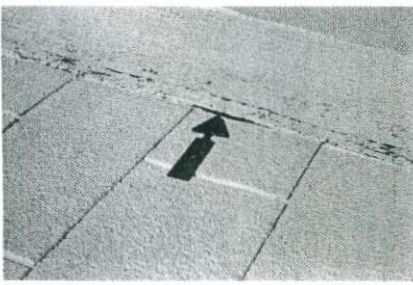
the roof was a bad combination. The paint was observed to bridge between overlying shingle tabs in some areas but not in others. Due to the low slope of the roof, the shingles were vulnerable to water penetration during high winds. Once the water penetrated the shingles, it could migrate laterally and become trapped under the elastomeric coating. Evidence of long-term water intrusion was noted in the discoloration of the white roof surface caused by corrosion of underlying roofing nails and soft areas in the plywood roof deck which were detected while walking on the roof.

The old roof shingles are covered here with an elastomeric coating. The arrow points to a gap in the roof which allowed moisture to penetrate and corrode metal flashings.

I am now convinced that my original assertion that the elastomeric coating was trapping water was correct. The extent of plywood damage, and the significant corrosion

of the roofing nails and flashing, was the direct result of long-term exposure to this trapped moisture.

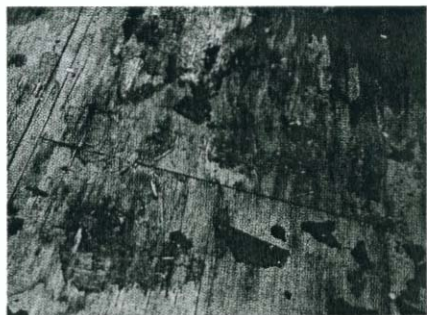
Damage from moisture intrusion also ruined vast expanses of the plywood roof decking, which had to be replaced.

As the shingles were being scraped away, it was quickly apparent that the middle of a large plywood area was completely rotten. I expected the roof deck to be deteriorated (water stained, delaminated, minor decomposition) in some areas, but not rotten. The wood was dark brown to black in color and extremely soft. If the plywood was this bad in the field, I figured it would be even worse at the eaves. As more of the roof was torn off, my fears were realized; the wood rot was widespread with no discernible pattern.

The roof deck preparation included removing and replacing any deteriorated plywood sheets (an unknown quantity at this point), fastening all the plywood roof deck to meet wind uplift requirements, and installing underlayment. The specified RoofGuard® underlayment is a hybrid woven product specifically designed for metal roofs. It's manufactured by UPM-Kymmene Corp. W. Rosenlew in Finland and marketed in the United States by Drexel Metals Corp.

If the extent of rotten plywood was similar on the remaining roof areas, the plywood replacement allowance would be drastically exceeded. The contract provided for an allowance of 10 sheets of plywood replacement. In the end, 128 sheets were needed, costing the owners of the buildings considerably more than originally allowed.

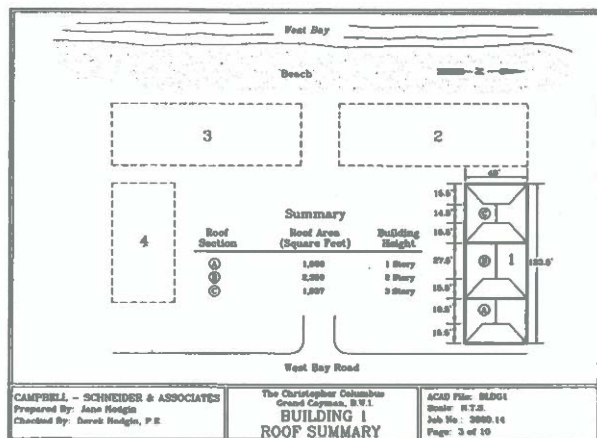
The complex, built in 1978, consists of four buildings containing a total of 31 units. Each building has three roof areas which vary in height from one to three stories. The roof areas are constructed in Dutch hip configurations with a 3:12 pitch. The total roof area of the four buildings is about 26,000 sq. ft. The existing roof assembly consisted of a 5/8-in. plywood roof deck, roofing felt, and three-tab composition shingles. The assembly is supported by prefabricated metal-plate-connected wood trusses.

This site plan illustrates the multi-story aspect of the project's four buildings. Buildings 1 and 4 have one, two, and three stories; buildings 2 and 3 have two and three stories.
