THE PROBLEM IS NOT EIFS — IT'S THE DETAILS

By Derek A. Hodgkin, PE, RRO, RRC

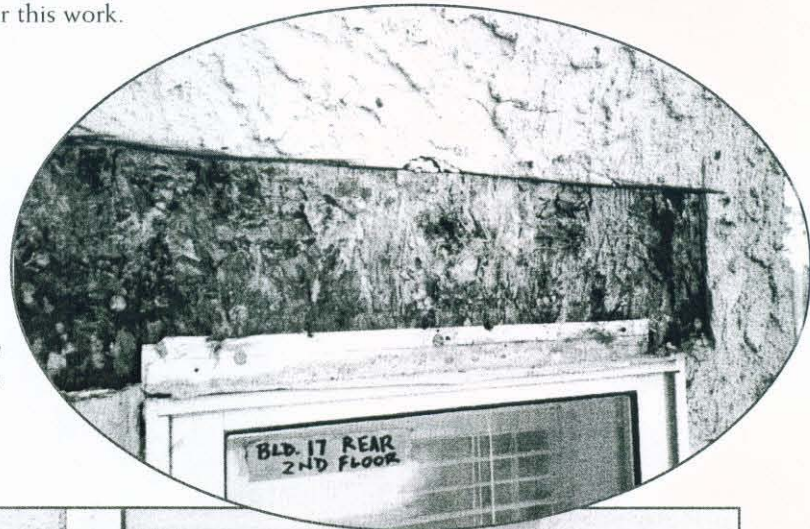
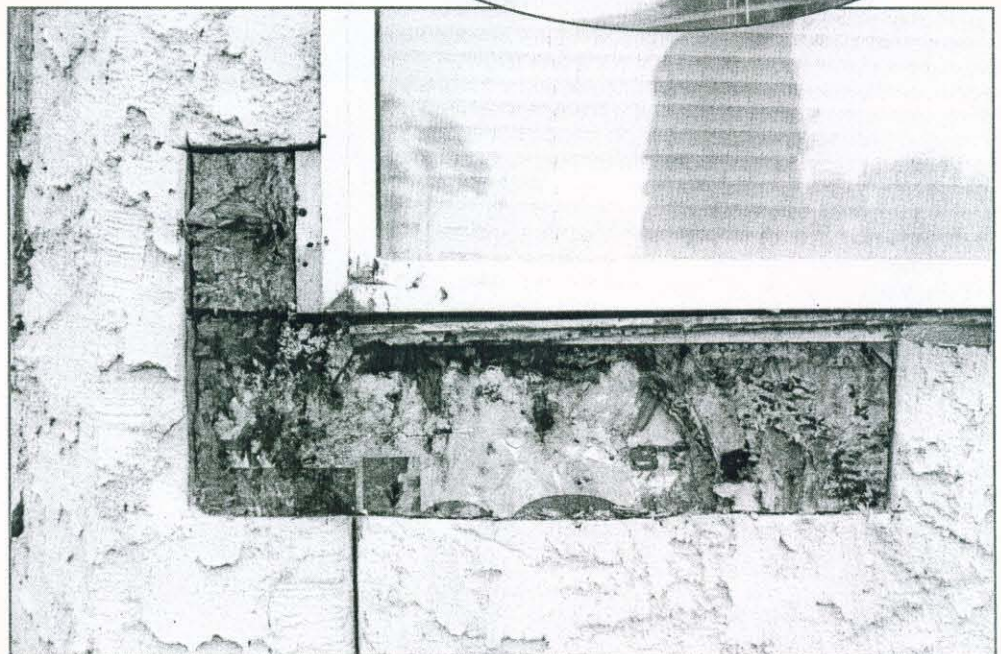
Water intrusion damages are frequently located adjacent to windows. The most common problems (which are often compounded by leaking windows) include improper wrapping of the rough opening and improper installation of head and sill flashing (*Photos 1 and 2*).

Photos 1 and 2: Views of damage above and below a window in a building with hard coat stucco.

Window rough openings should be properly wrapped. Head and sill flashing should be installed and properly integrated with adjacent building components (i.e., weather barrier). The American Society for Testing and Materials (ASTM) International Standard E 2112, issued in 2001, and the American Architectural Manufacturers Association (AAMA) *Installer Training Manual*, published in 2000, serve as excellent references for this work.

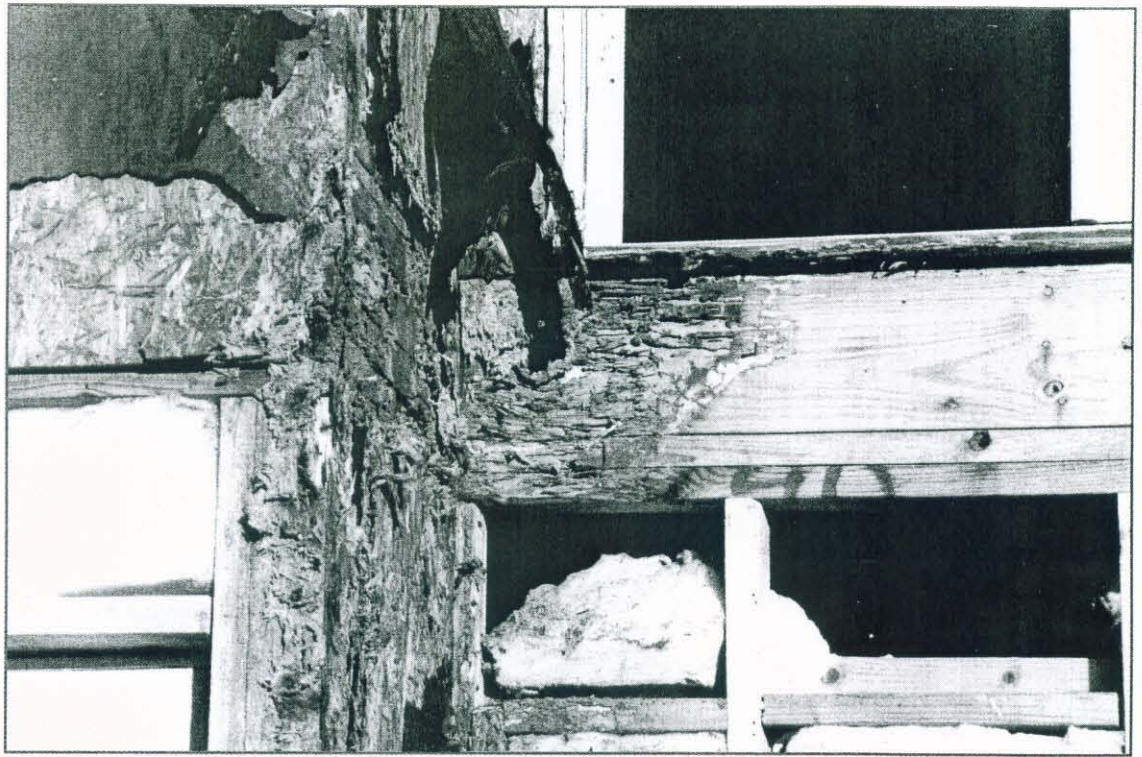
Entry doors and sliding glass doors can admit significant amounts of water behind a cladding system if proper waterproofing details are not present. The damages can be particularly devastating when large doors are used on walls with exposure to wind-driven rain. In these cases, the author has observed damages below the unsealed jamb/threshold intersection at the bottom corners of the door. This problem can be exacerbated when the door threshold is installed at the same elevation as an adjacent walkway, deck, balcony, or threshold if it is improperly integrated into the deck waterproofing system (Photo 3).

Photo 3: View of damages below a jamb/threshold intersection on a building clad with wood siding.

Door openings should be wrapped in the same manner as window openings. Additionally, a more significant waterproofing membrane, metal pan, or both should be installed below the threshold. All waterproofing materials should be properly integrated with adjacent building products to provide a continuous drainage path.

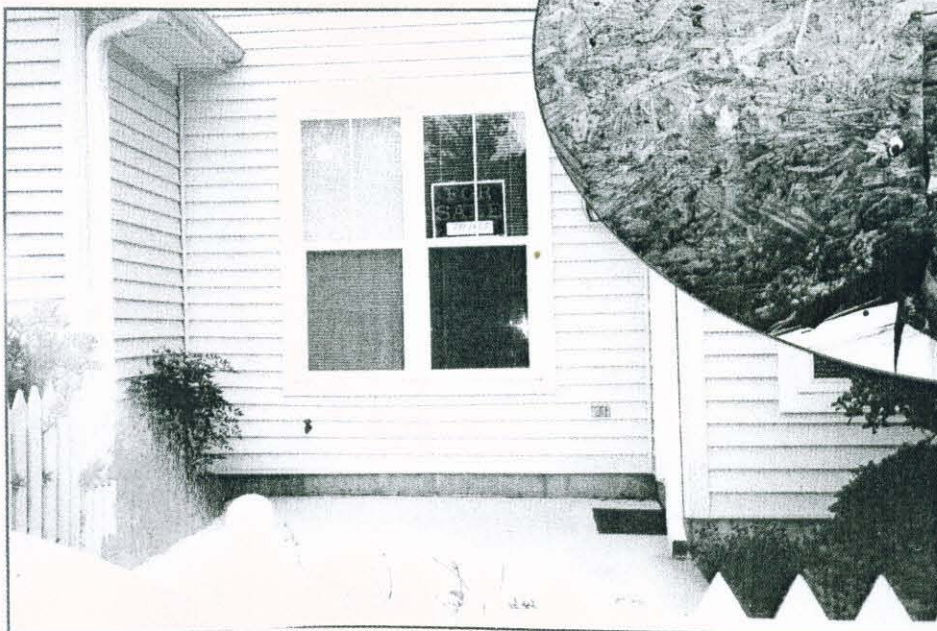
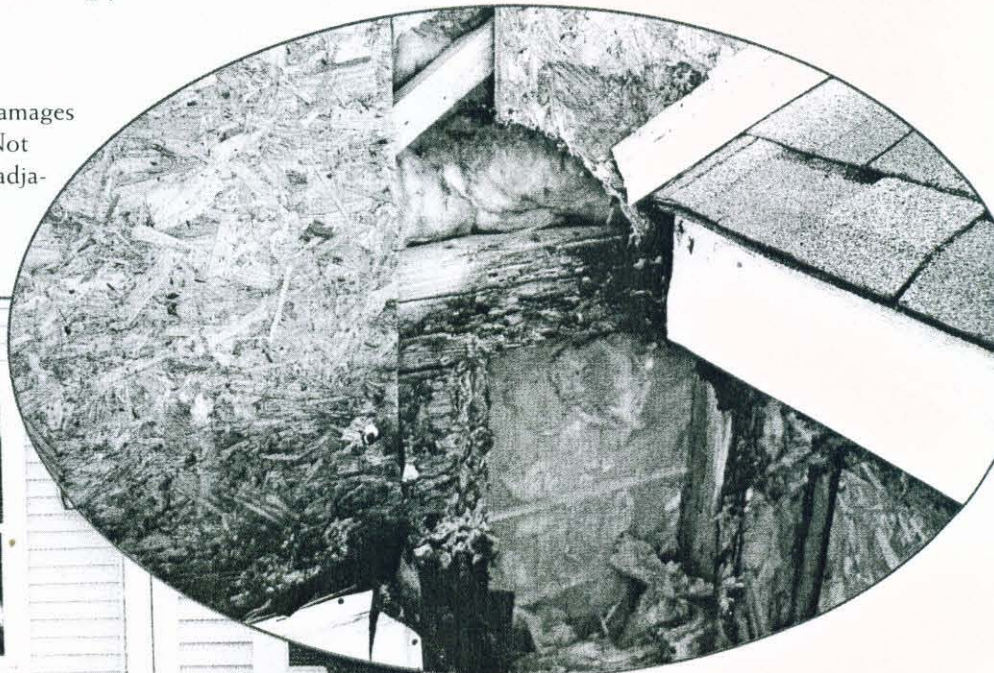
Some of the most significant water-related damages exist at roof/wall intersections (Photos 4 and 5). Not only does this area collect the most water from adjacent roof areas, it can distribute the water over great vertical distances with the help of gravity.

In some instances, a small roof area can serve to rot three stories of wood framing due to a lack of proper waterproofing.

Photos 4 and 5: Views of significant damages below a roof/wall intersection on a building clad with vinyl siding.

Waterproofing at roof/wall intersections is somewhat dependent on the cladding type. However, the waterproofing concepts are all the same. The adjoining roof and wall areas must be protected using underlayment (typically asphalt-saturated felt or self-adhering membrane). Additionally, metal flashing should be used to prevent water penetration and to divert water away from the wall assembly. This flashing detail is commonly referred to as a "kickout."

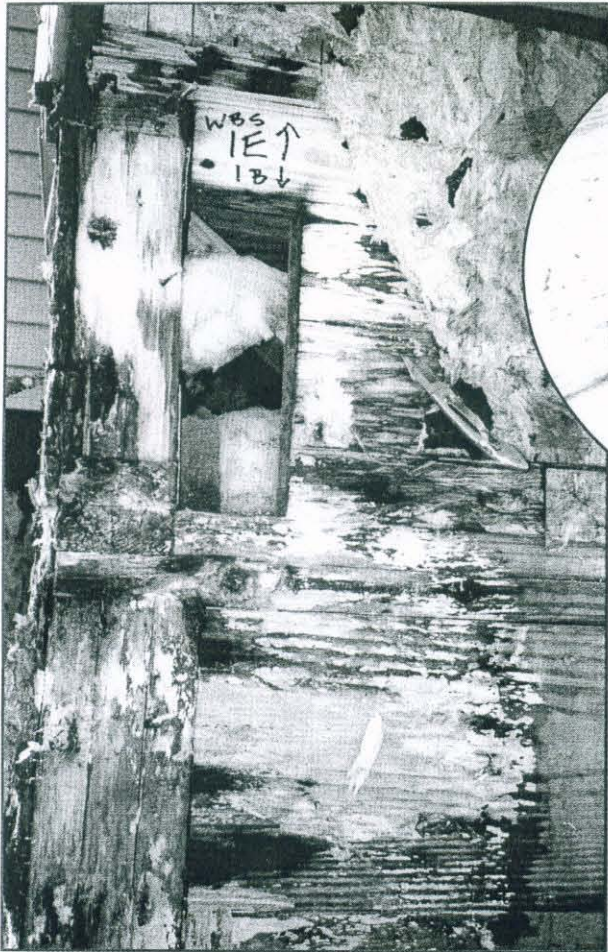
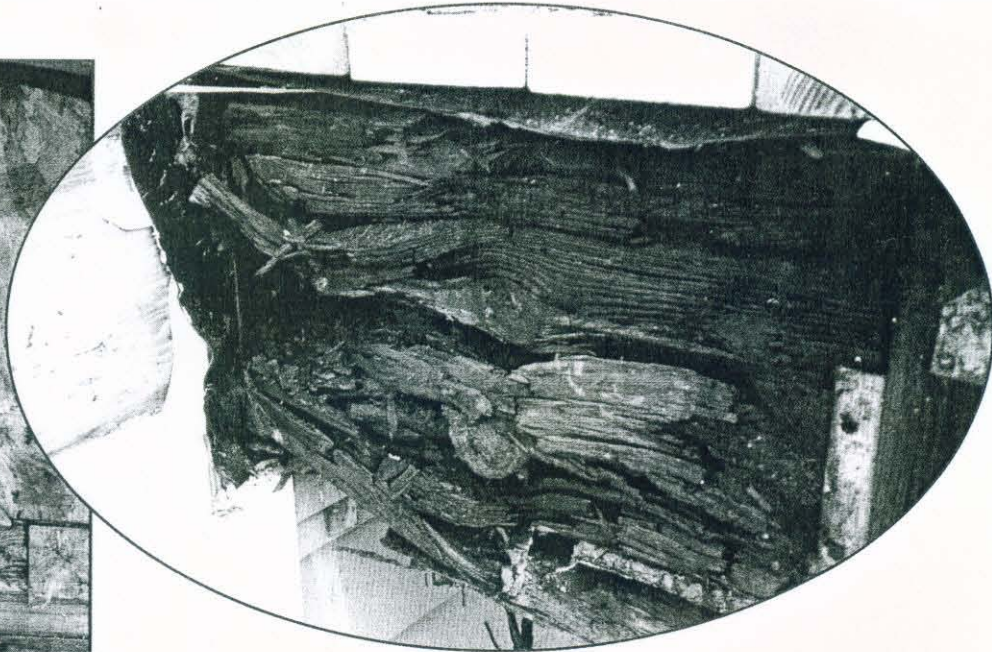
Photos 6 and 7 show water-damaged building components caused by improper waterproofing details at a deck. These buildings were clad with wood siding.

Special attention must be paid to areas where decks interrupt wall cladding systems. The concept is simple: maintain a continuous drainage plane behind the deck. However, due to the number of building components (and trades) located in a relatively small area, the best efforts may be compromised by the end of a project (Photos 6 and 7). The trades (framer, waterproofer, door installer, siding installer, and deck builder) must coordinate their efforts to achieve the desired leak-free assembly.

The drainage plane must not be interrupted. The building components in the area must be properly integrated (i.e., wall cladding components, wood deck members, metal flashing, weather barrier, waterproofing membrane, and doors). Adequate space between products must be provided such that water can flow along an uninterrupted and unrestricted path. These details should be considered in conjunction with other waterproofing details such as the door details described previously.
