UNREINFORCED MASONRY WALLS STRENGTHENED WITH ORTHOGONAL NEAR-SURFACE MOUNTED CFRP SUBJECTED TO OUT-OF-PLANE LOADING

R. SERACINO

J.C. WYLIE

Department of Civil, Construction, and Environmental Engineering, North Carolina State University,
Raleigh, North Carolina, USA

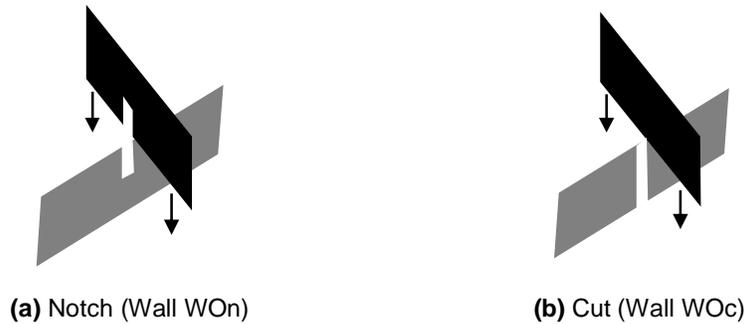
Fig. 1 Construction techniques for orthogonal NSM grid.

One wall, WC, was tested as a control with no strengthening. The remaining four walls were strengthened on the tension face using the NSM technique with 25.4 mm wide by 1.90 mm thick CFRP strips having a tensile modulus of 139000 MPa. Grooves were cut with a circular saw to a width of approximately 5.7 mm and a depth of 25.4 mm. Note that at this depth the groove passed through the cores, which made it difficult to ensure that the groove was completely filled with adhesive. The CFRP was adhesively bonded into the grooves according to the manufacturer's recommendations. Four NSM strips were used in both the horizontal and vertical orientations spaced at approximately 457 mm from the edges of the wall and 406 mm between adjacent strips. The grooves were located such that they would not coincide with mortar joints in the longitudinal direction. Note that the use of a circular saw did not allow the grooves to be cut all the way to the left, right, and bottom edges of the wall. One of the strengthened walls only had horizontal NSM CFRP strips, WH, and one wall had only vertical NSM CFRP strips, WV. The other two walls, WOn and WOc, were strengthened with an orthogonal grid of NSM CFRP strips. Due to the narrow thickness of the single-wythe wall both vertical and horizontal NSM strips were located at the tension face, hence, two construction techniques were considered at the intersection points of the grid. The first approach cut notches in the FRP where the horizontal and vertical strips intersect, as illustrated in Figure 1a. This approach was used in wall WOn. The second approach involved cutting through the horizontal FRP strips after they were installed to allow the vertical strips to pass across them, as illustrated in Figure 1b. The horizontal

strips were cut as they were expected to contribute less to the out-of-plane bending resistance of the strengthened walls. This approach was used in wall W0c.

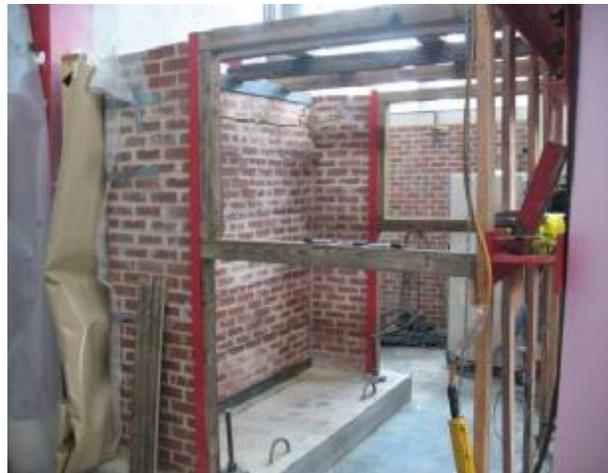
Fig. 2 Overall view of experimental test set-up.

Figure 2 gives an overall view of the experimental test set-up. Steel angles were used at the top and bottom edges of the wall to restrain the wall from out-of-plane displacement. The angles also served to anchor the vertical FRP strips by preventing them from displacing out-of-plane relative to the wall. No form of FRP anchorage was provided near the ends of the horizontal FRP strips. The return walls were also prevented from displacing or pivoting about their base by tying them to an external reaction frame. The supports on all four edges were designed to allow two-way bending to develop. It is also expected that some degree of rotational restraint would be provided along all four edges. An airbag was used to apply the out-of-plane loading, and no precompression was applied to the wall. Instrumentation included string potentiometers to measure out-of-plane displacement, and electrical resistance strain gauges that were attached to the FRP where cracks in the masonry were expected to occur. The out-of-plane displacement field was also measured using an optical sensing technique, but the data has not been processed at the time of writing this paper.
